## **PolyMet Tailings Seepage Briefing (November 2015)**

Paula Maccabee, Advocacy Director/Counsel for WaterLegacy

### How significant is seepage from the PolyMet tailings waste facility?

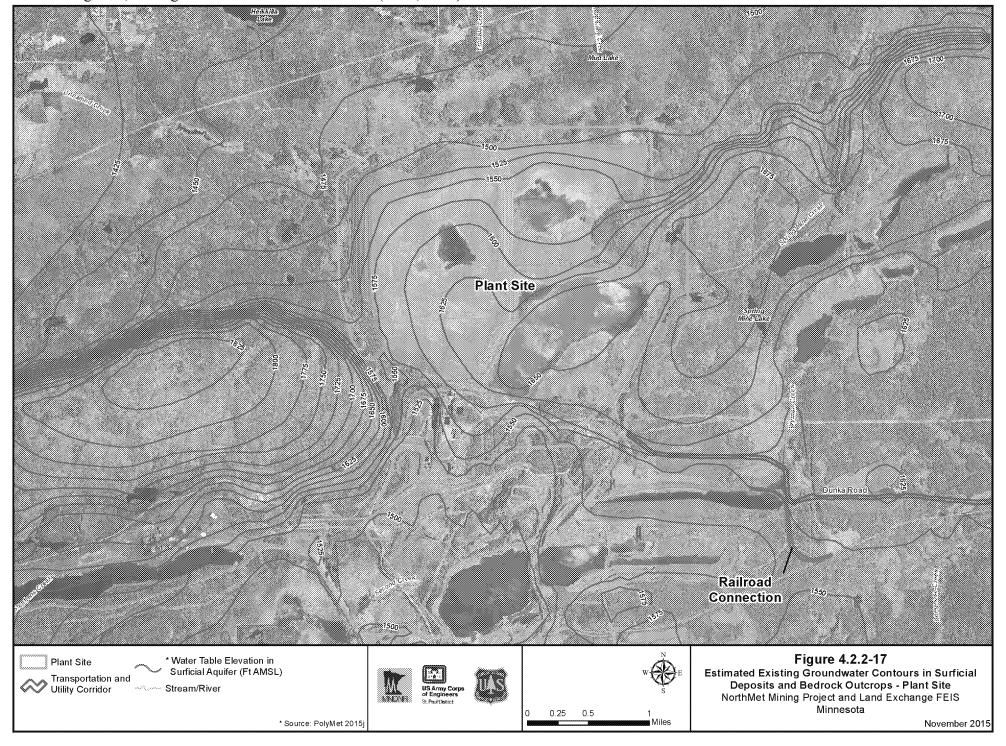
Figure 6, Tailings Site Groundwater Elevations (FEIS, 2015)

- The completed tailings height of the PolyMet waste cells would be 1,735 above sea level. (FEIS 3-104). That is 60 feet higher than the highest feature to the east and more than 200 feet higher than gradient on the west, northwest, north and south sides of the tailings. (See Figure 6). Elevations above surrounding land creates hydraulic pressure for seepage.
